Manhole Inspection Summary

Manhole # S25GG_014MH

Insp Date: **9/5/07 10:44 AM**

Location Address: **512 ROBERT ST**

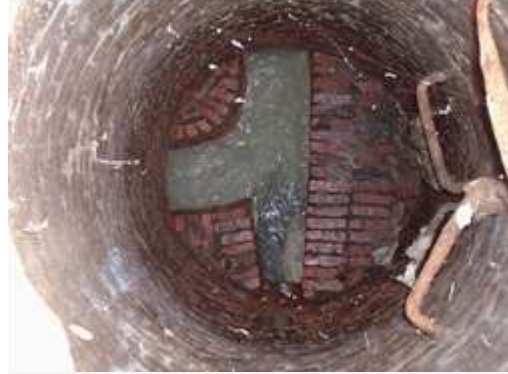
Top View

Corroded steps. Evidence of surcharge - Bench debris.

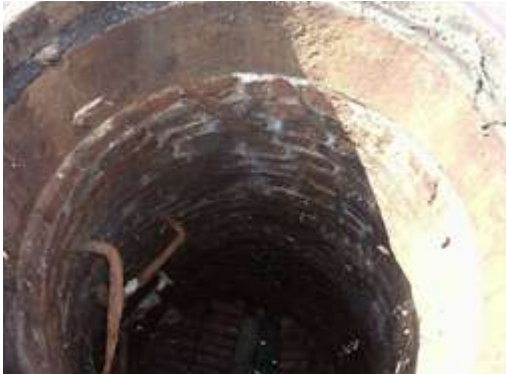
Defect

Frame leaks. Adjustment deterioration and infiltration. Barrel infiltration - other side.

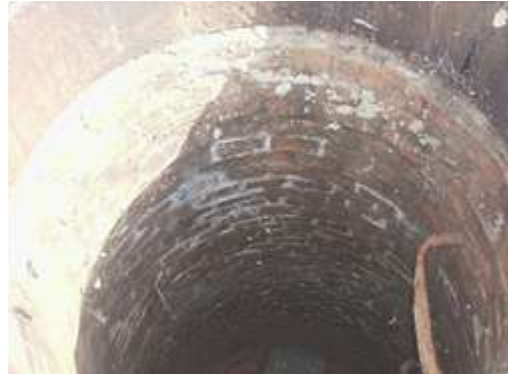
Defect

Frame leaks. Adjustment deterioration and infiltration. Barrel infiltration

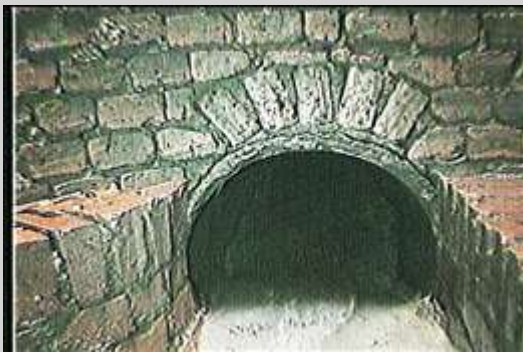
8 in. Circular Gravity Sewer Pipe Out @ 12 O'Clock

Barrel deterioration and infiltration. Bench and Channel deterioration.

Infiltration: **Evidence** Pipe Seal Cond: **Cracked**

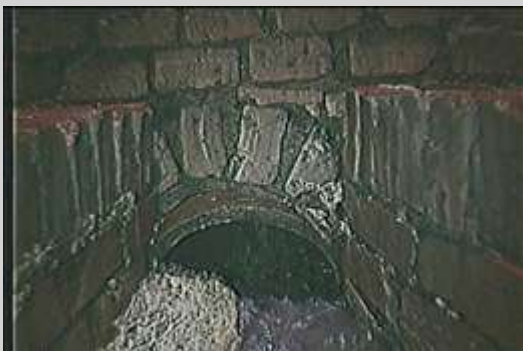
8 in. Circular Gravity Sewer Pipe In @ 6 O'Clock

Channel root intrusion.

Infiltration: **None** Pipe Seal Cond: **Roots**

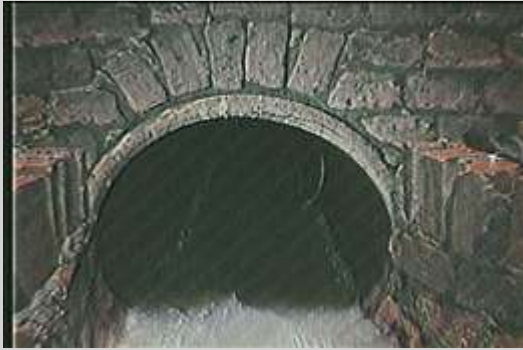
Pipe In @ 9 O'Clock

Barrel deterioration and infiltration. Channel deterioration.

Infiltration: **None** Pipe Seal Cond: **Cracked**
